Dover Dam Dam Safety Assurance (DSA) Project Dover, Ohio

Phase I HTRW Environmental Site Assessment

U.S. Army Corps of Engineers
Huntington District
Environmental and Remediation Section
October 2006

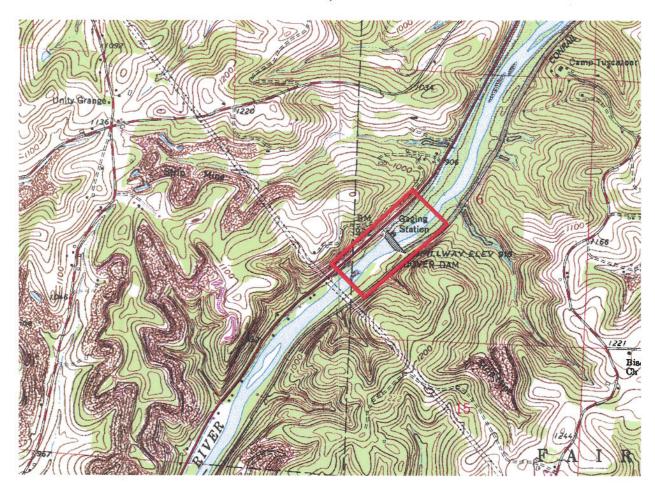
Dover, Ohio USGS Topographical Map Scale 1:24000 The Contract Work Limits are identified with red outline.

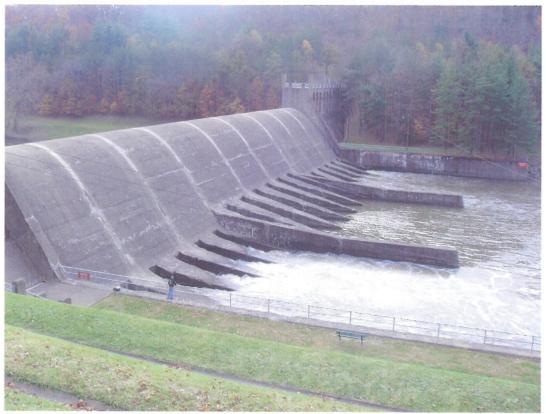
Photo 1 – View of Dover Dam.

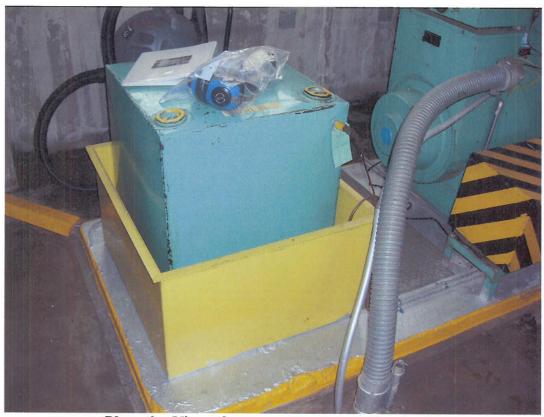
Photo 2 – View of emergency generator diesel tank.

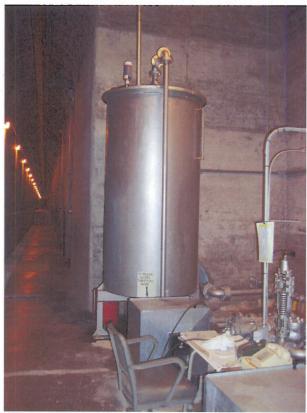
- It was noted during the site visit that hydraulic oil is used to raise and lower the gates of the dam. It was apparent in a few of the gates that they had leaked oil in the past. Approximately 7 feet away from all of the gates is a series of grating. It was obvious that in a few instances the gates which leaked the hydraulic oil did so directly into this grating. The grating also houses the foundation drains of the dam, which act as relief wells during high flow times, allowing water to be pushed up into the dam. Dover Dam personnel said they had never observed the drains leave the pipes into the grating. As it was described to EC-CE personnel, if water were to overflow from the foundation drains and get into the grating the water would be transported back to the river via a sump pump. Even though oil could possibly be released into this grating system, it is unlikely that the oil would be transported to the bedrock underneath the dam via the foundation drains due to the fact that water has not reportedly overtopped the foundation drains.

Photo 3 – View of hydraulic oil tank located in Dover Dam gallery.

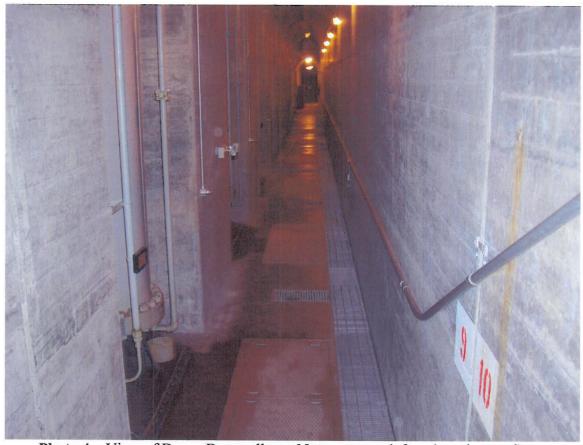
Photo 4 – View of Dover Dam gallery. Note gates on left and grating on floor.

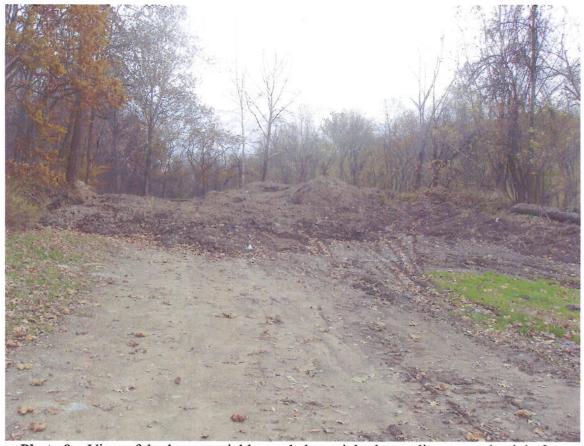
- There was a large area of dredge material disposed of along the second streambank tier upstream from the dam. During a closer inspection of this material, there were several small areas where a liquid with sheen was leaking from the dredge material. It was apparent that the material was put in this location to decant water following dredging from the upstream side of Dover Dam. The water from the discarded dredge material was allowed to flow back over land to the Tuscarawas River from the decant location.

Photo 9 – View of dredge material located along right descending streambank before dam in CWL.

- During the site visit it was noted that USACE personnel at Dover apply (or have applied) dredged material to an area near both the left and right hand descending streambank above the dam to decant the water from the material prior to disposal. It is recommended that soil samples be taken of the dredge material and soil underneath the dredge material. This recommendation is made to ensure that no HTRW or other contamination is present in the dredge material that has been applied to these areas.

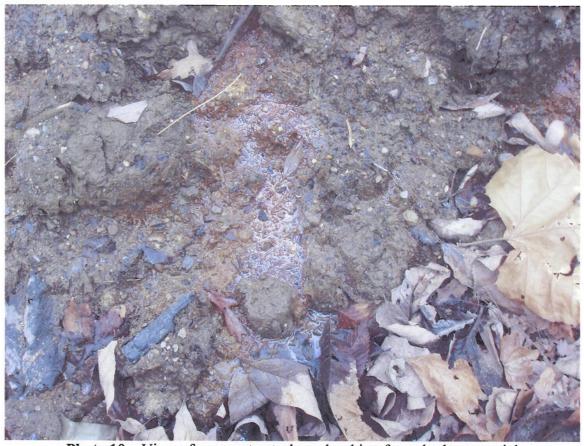
Photo 10 - View of apparent petroleum leaching from dredge material

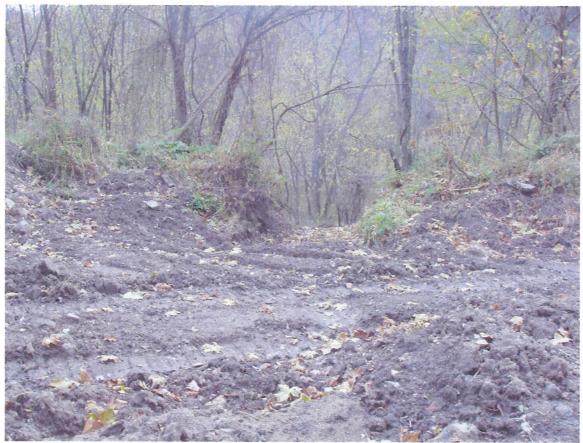
Photo 11 – View of area where dredge material releases dredge material water back to Tuscarawas River.

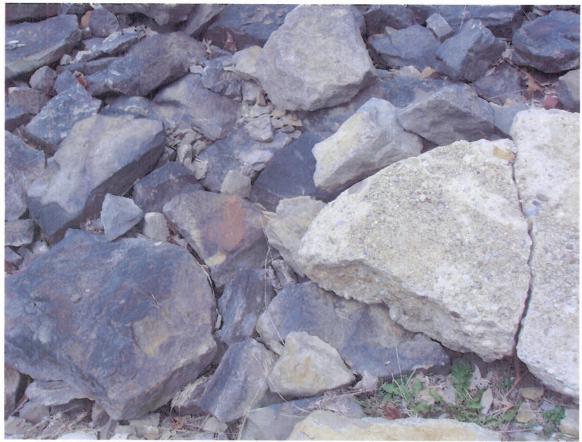
- There is a large area of discolored rock below the parking area upstream of the dam. The rock appeared to be fairly heavily stained but it was unclear whether this happened while the rock had been in that location or whether the rock had been delivered that way.

Photo 13 – View of discolored rock located above abutment located along right descending streambank before dam in CWL.

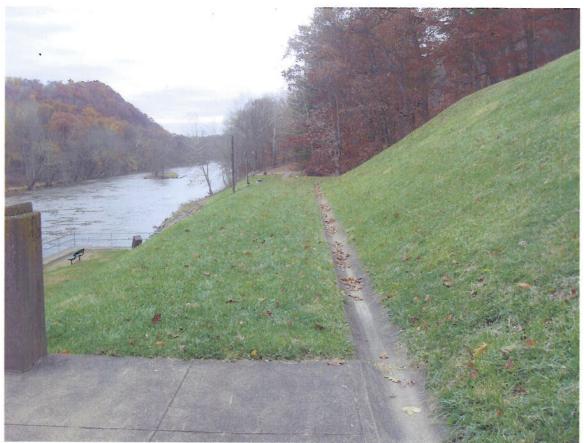
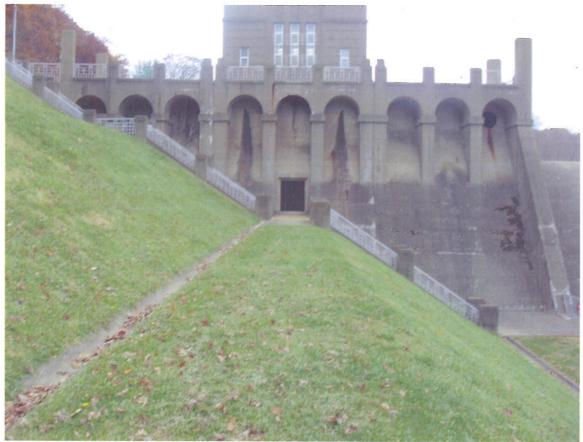
Photo 14 – View of approximate area where petroleum was encountered during drilling. This site is located along right descending streambank following the dam in CWL.

Photo 15 – View of approximate area where petroleum was encountered during drilling. This site is located along right descending streambank following the dam in CWL.

- Due to a 2004 USACE boring that revealed possible petroleum contamination located near the dam, it is recommended that soil and groundwater samples be taken in the area around EC-GS boring C-04-05. This is in reference to the petroleum that was encountered during drilling in the right-hand bench downstream from the dam.

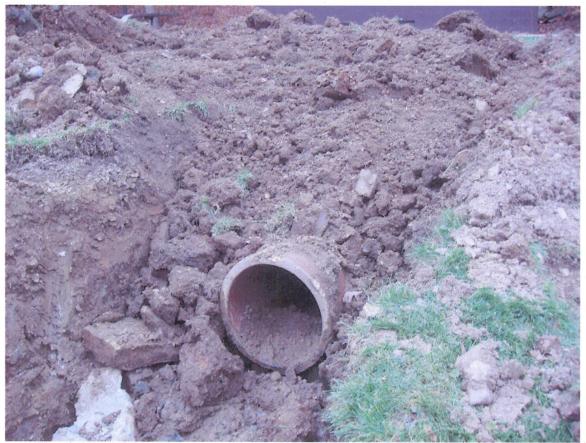
Photo 17 – View of stormwater pipe located along right descending streambank following the dam in CWL.

- If additional poles or discarded materials are found during construction in the area surrounding where the power pole was found while Dover Dam personnel excavated for

- the stormwater pipe, EC-CE should be notified to determine the need for additional investigation regarding the poles or other wastes that may be encountered.
- It should be noted that the entire downstream portion of the proposed access road was not accessed during the site visit due to inclement weather and the accelerated schedule associated with this project. Recommendations given within this report are made based on the portions of the proposed access road that were accessible during the site visit, as well as photos that were taken by other USACE personnel who conducted site visits prior to this report. It is recommended that during the DDR phase, EC-CE conduct a complete walkthrough of the entire proposed access road to clear the area of HTRW concerns.

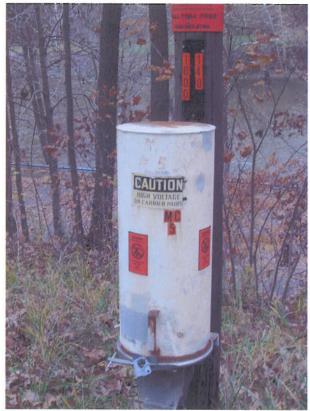
Photo 20 – View of transformer located along State Route 800.

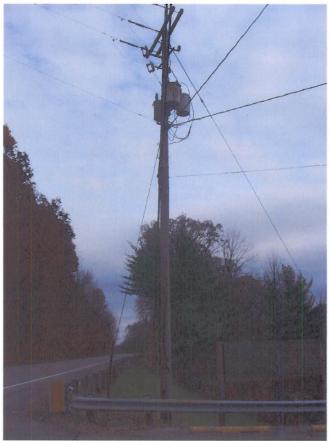
Photo 21 – View of transformer located along State Route 800.

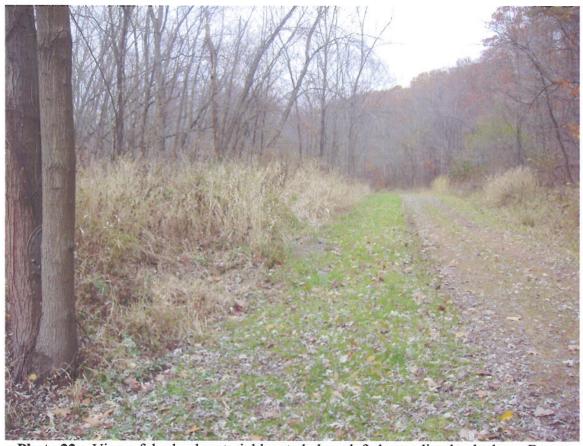
• There was an area of dredge material disposed of along the streambank upstream from the dam. It was apparent that the material was put in this location to decant water following dredging from the upstream side of Dover Dam. The water from the discarded dredge material was allowed to flow back over land to the Tuscarawas River from the decant location. While excavating to replace a stormwater pipe, project personnel encountered what was believed to be a portion of a power pole. It was unclear whether this pole was just a single instance or a portion of a greater dump area.

Photo 22 – View of dredged material located along left descending bank above Dover Dam (adjacent to proposed upstream access road).

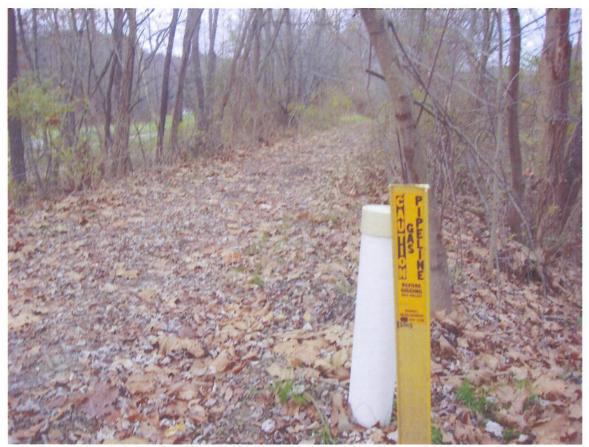
Photo 25 - View of gas line adjacent to proposed access road below Dover Dam.

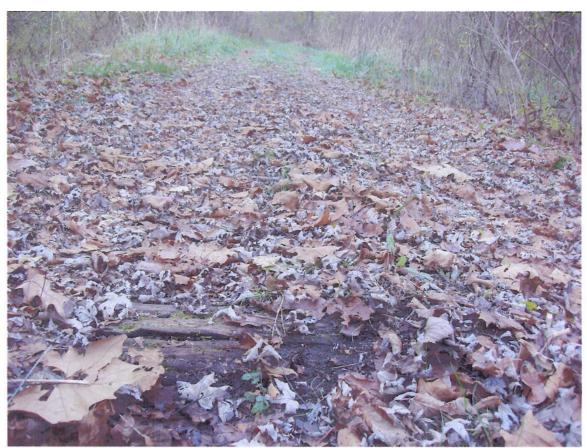
Photo 26 - View of railroad tie located along proposed access road below Dover Dam.

- Ohio EPA and the receiving landfill require that samples of the railroad ties, and soil
 where the ties lay, be taken for disposal purposes. Though not considered a hazardous
 waste, railroad ties are still required to be subjected to Toxicity Characteristic Leaching
 Procedure (TCLP) analysis prior to disposal at the appropriate facility.

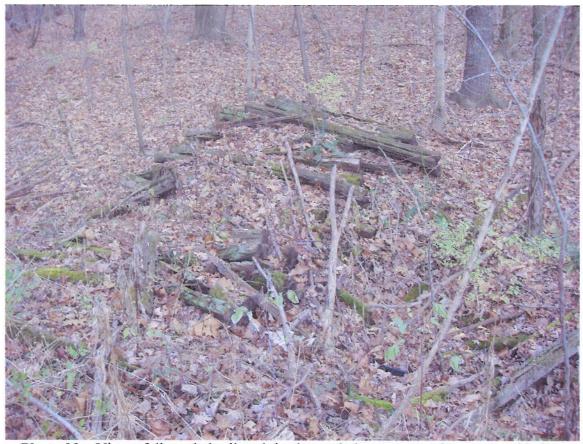
Based on the field investigation there is evidence that the area with abandoned railroad ties may contain environmental concerns that would impact the proposed CWL. Ohio EPA and the receiving landfill require that samples of the railroad ties, and soil where the ties lay, be taken for disposal purposes. Though not considered a hazardous waste, railroad ties are still required to be subjected to Toxicity Characteristic Leaching Procedure (TCLP) analysis prior to disposal at the appropriate facility.

Photo 28 – View of discarded railroad ties located along proposed access road below Dover Dam.

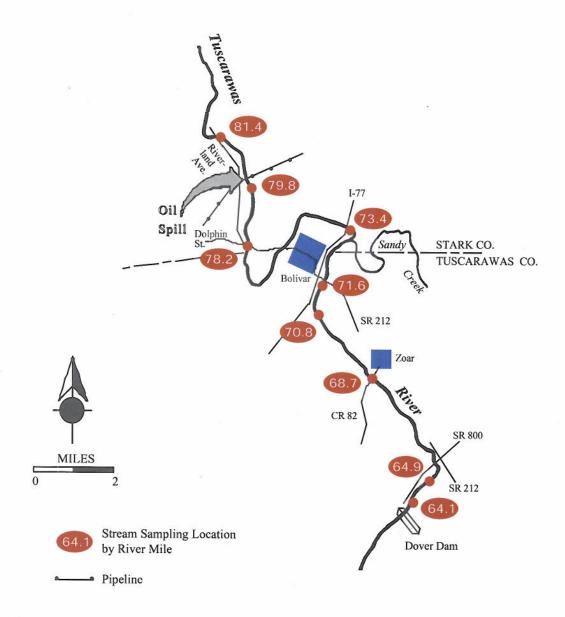
Figure 1. Map of the Tuscarawas River study area showing principal streams, landmarks, the oil spill location and Ohio EPA biological sampling locations, 1995.

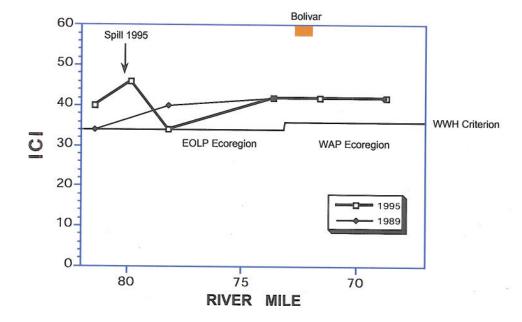
Figure 2. Longitudinal performance of the Invertebrate Community Index (ICI) in the Tuscarawas River for 1989 and 1995.

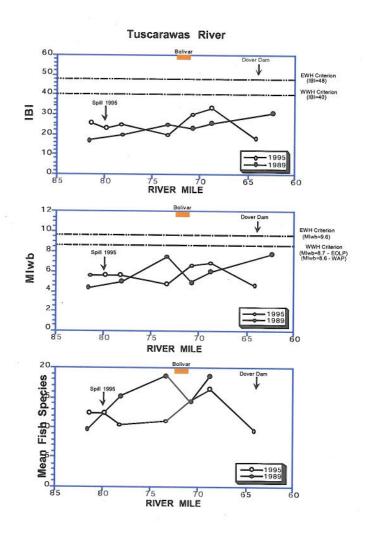
Figure 3. Longitudinal performance of the Index of Biotic Integrity (IBI), the Modified Index of Well-being (MIwb), and mean number of fish species in the Tuscarawas River, 1989 and 1995.

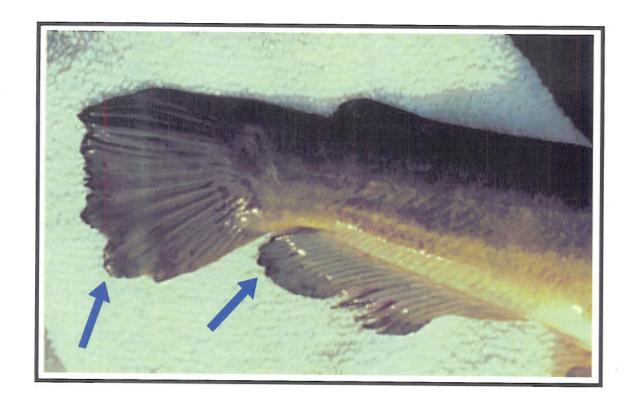
Plate 1.Photo of a yellow bullhead showing blackened fin margins; collected from the Tuscarawas River at RM 79.8, June 19, 1995.
